QUINNIPIAC RIVER BASIN  
PROSPECT , CONNECTICUT

**CHESHIRE RESERVOIR DAM**  
**CT 00303**

**PHASE I INSPECTION REPORT**  
**NATIONAL DAM INSPECTION PROGRAM**

APRIL 1980

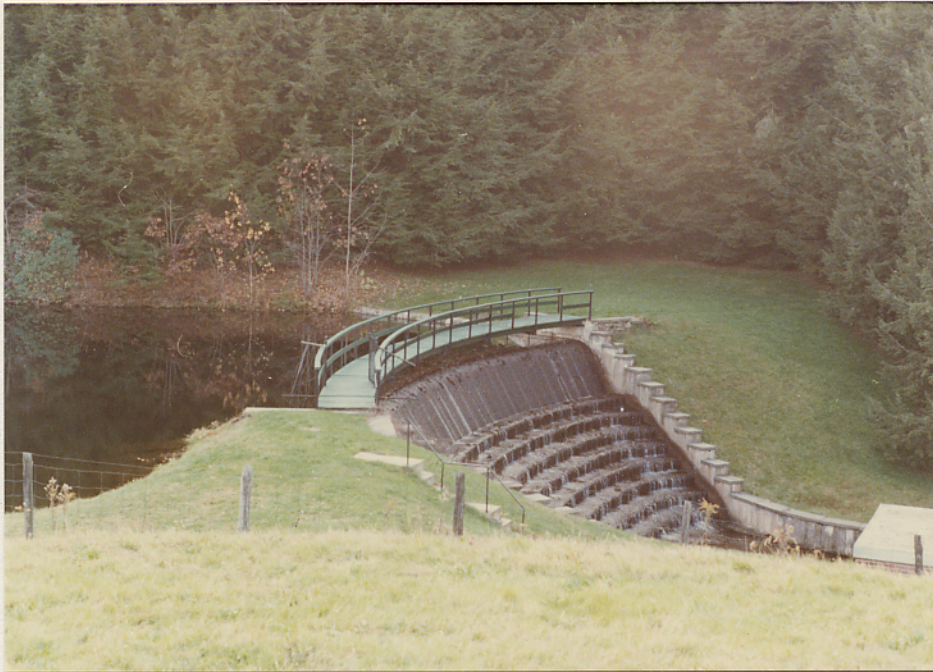
2) Crest - The crest of the dam appears fairly constant in elevation. Very slight wear on the grassed surface was noted (Photo No. 1).

PHOTO #1: Overview, from right abutment.

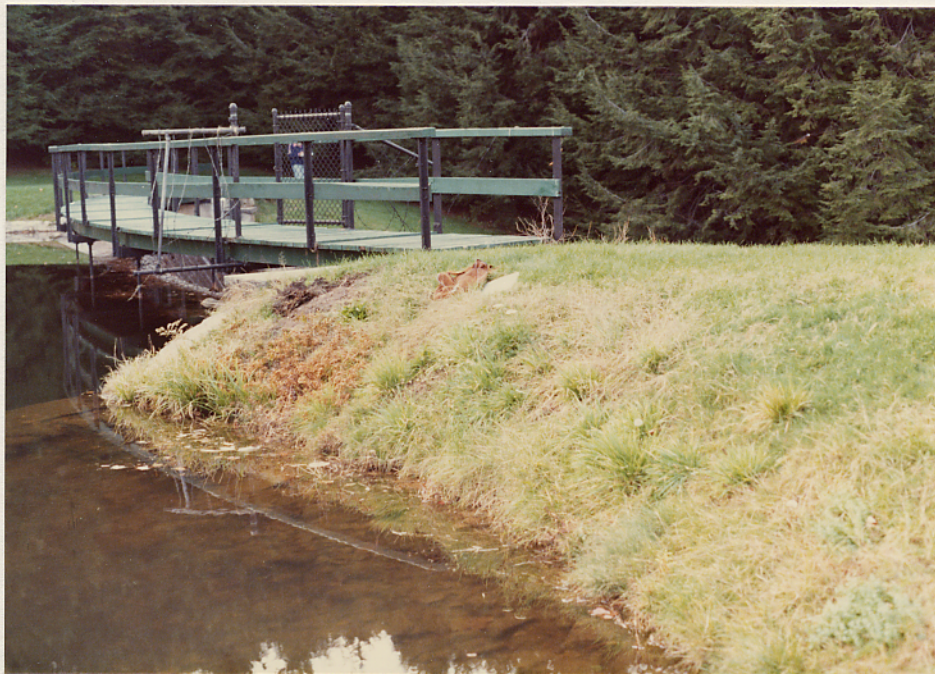
The absence of riprap on the upstream face will allow continued erosion and slumping of the slopes. The partial collapse of the stone wall along the crest of the dam to the left of the spillway could lead to erosion of the crest of the dam which could eventually result in failure of the dam.

PHOTO #2: Upstream face, from right side.

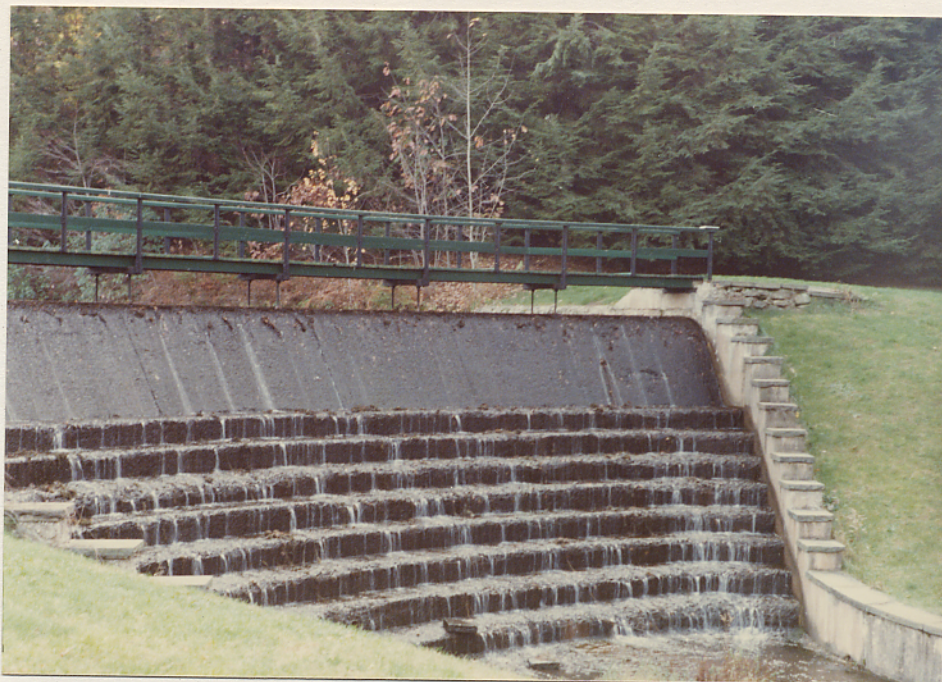
f. Footbridge. The wooden footbridge over the spillway is painted and in good condition (Photo No. 1, No. 2 and No. 3).

PHOTO #3: Spillway.

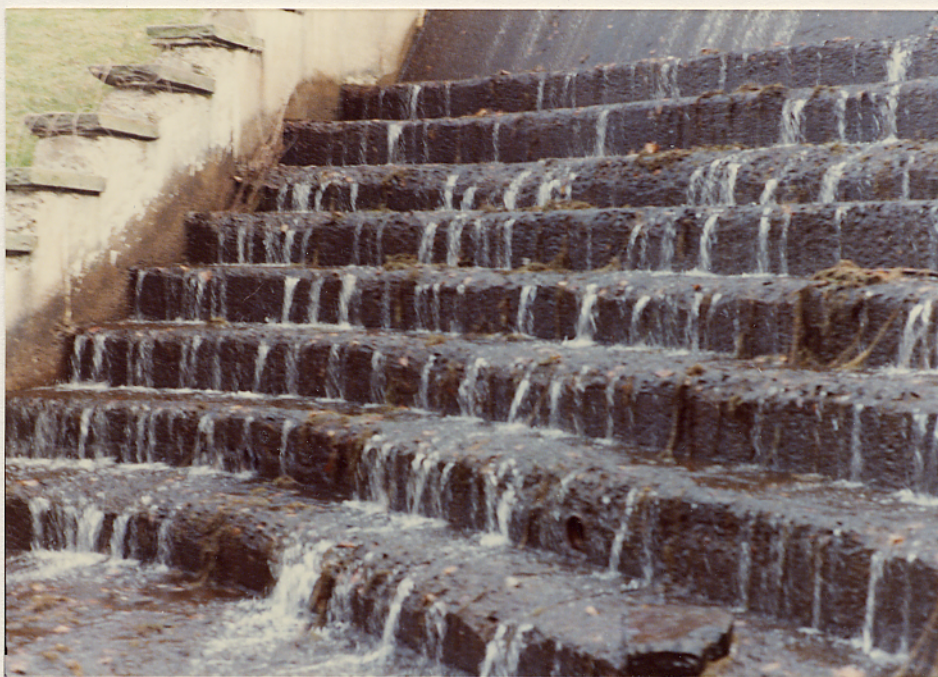
4) Spillway - The concrete spillway has rounded crest that discharges through the dam on a series of concrete steps (Photos No. 1, No. 3 and No. 4). The concrete surface has areas of extensive erosion, as indicated in Photo No. 4. Concrete spalling was noted on both the left and right training walls (Photo No. 8). Efflorescence was also observed. The spillway discharges into a concrete apron that in turn discharges into a stone lined channel. The concrete apron is in generally good condition. Grass and weeds are growing through the voids in the stone lined channel.

PHOTO #4: Spillway steps (detail).

3) Design and repair spillway steps and training walls.

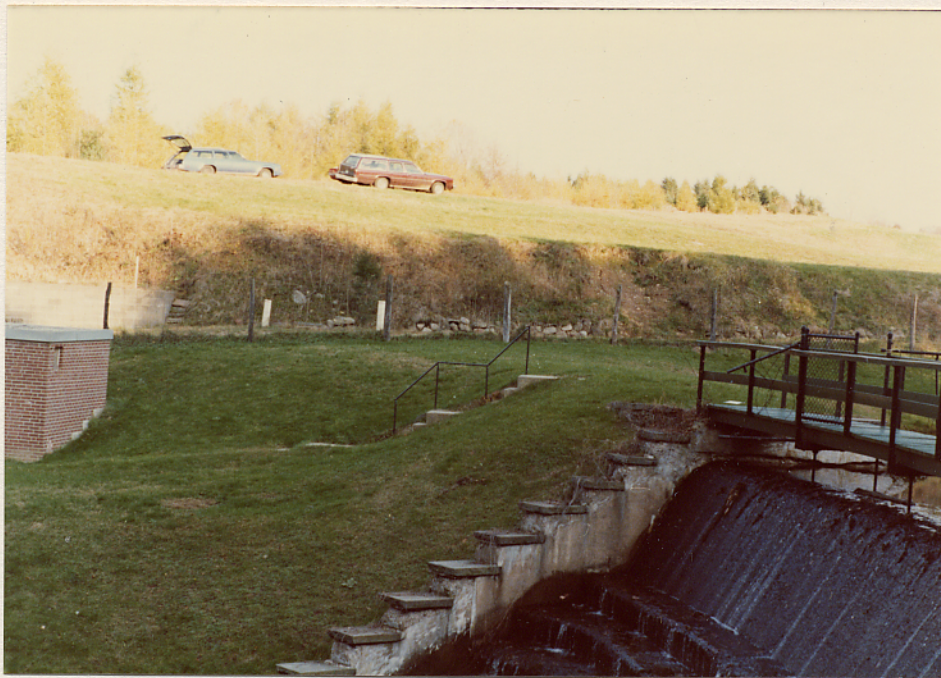
PHOTO #5: Right abutment.

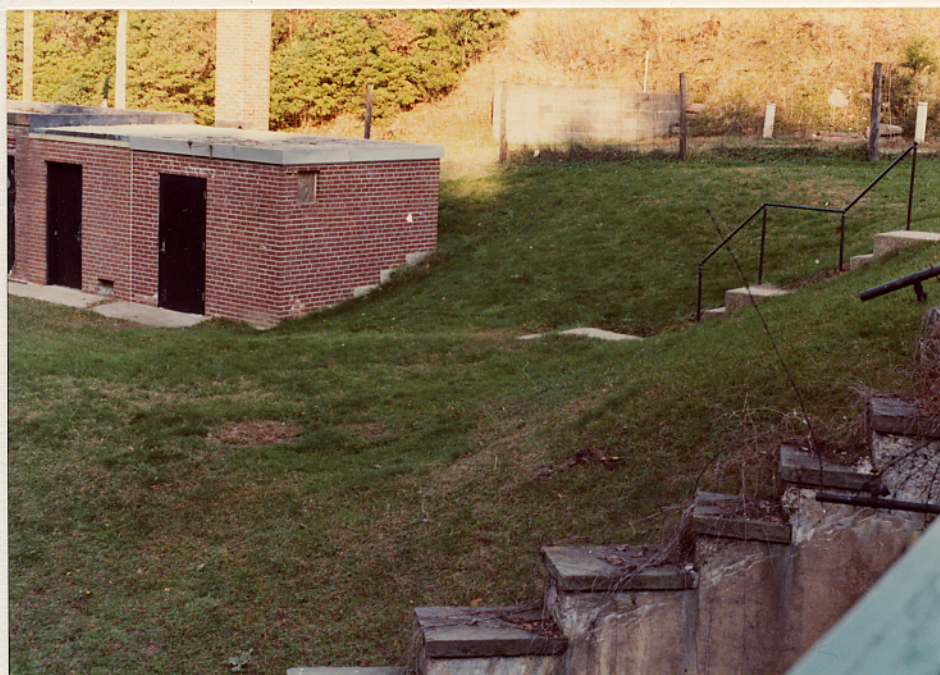
3) Downstream Slope - The downstream slopes of the embankment sections were generally grass-covered and well-maintained (Photos No. 1, No. 5 and No. 6). A small section of the 2-ft.-high stone wall has collapsed near the crest of the dam to the left of the spillway. Small animal burrows, approximately 2 to 3 in. in diameter, were noted at numerous locations just below the surface of the downstream slopes.

PHOTO #6: Downstream slope on right side of spillway.

4) Design and repair collapse of the stone wall on the downstream crest of the dam to the left of the spillway structure.

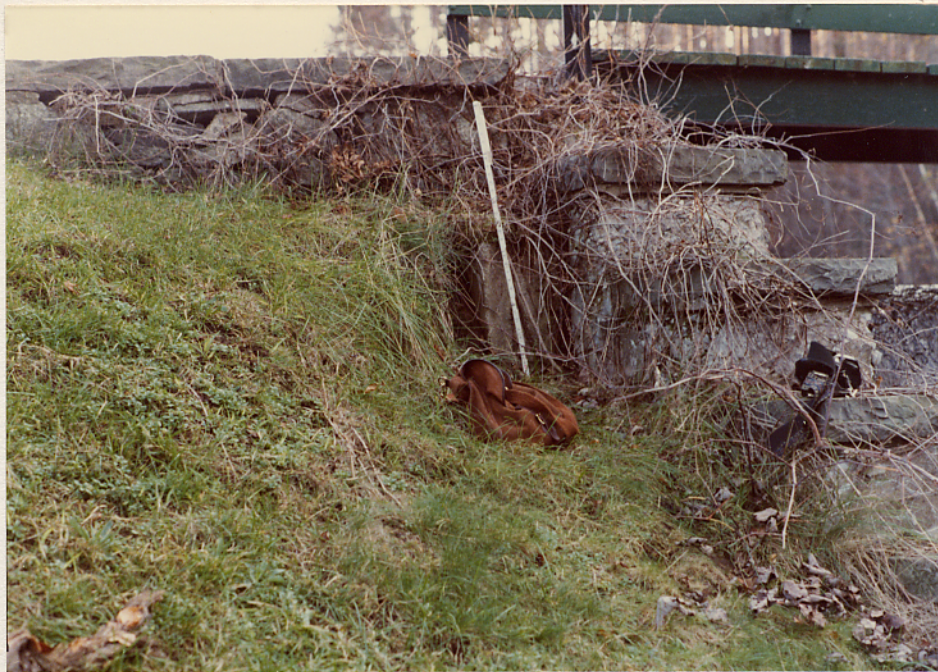
Erosion has occurred at several locations adjacent to the spillway wingwall along the downstream slopes and downstream from the toe. The erosion depressions are up to 18 in. deep and some of the soil may have been carried through the cracks and joints in the spillway training wall. An example of one of the erosion features can be noted in Photo No. 7.

Erosion has developed adjacent to the spillway wingwalls on both sides of the spillway channel. This condition could lead to piping and internal erosion of the dam if not corrected.

PHOTO #7: Erosion adjacent to right spillway training wall.

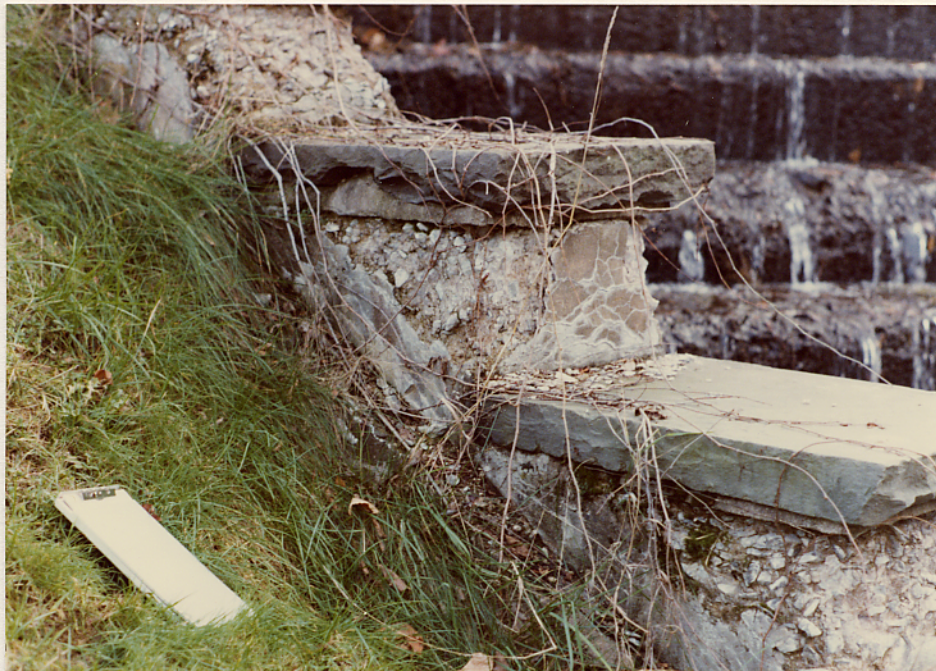
of extensive spalling, efflorescence, and erosion. The training walls have deteriorated and aggregate is visible. The gatehouse is in good condition.

PHOTO #8: Right spillway training wall (detail).

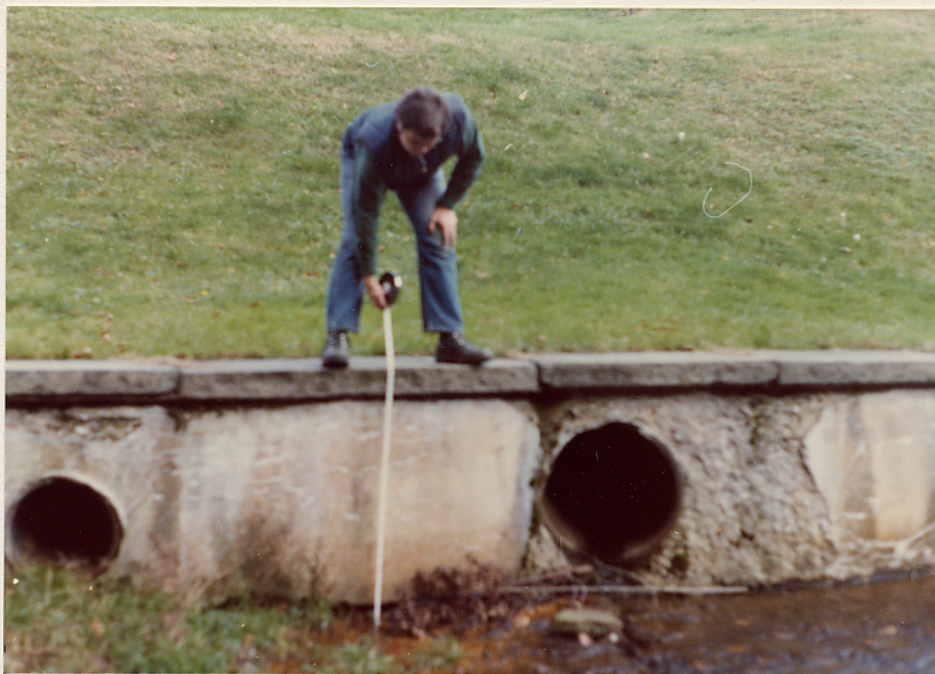
c. Appurtenant Structures. The exterior of the brick gatehouse is in good condition as indicated in Photo No. 11 (the interior was not inspected). The outlets of the 16 inch C.I.P. and 24 inch C.I.P. blow off pipes were located (Photo No. 9) and both pipe ends were in good condition and free of debris. The conduits have control valves located in the upper gatehouse.

PHOTO #9: Blowoff outlets.

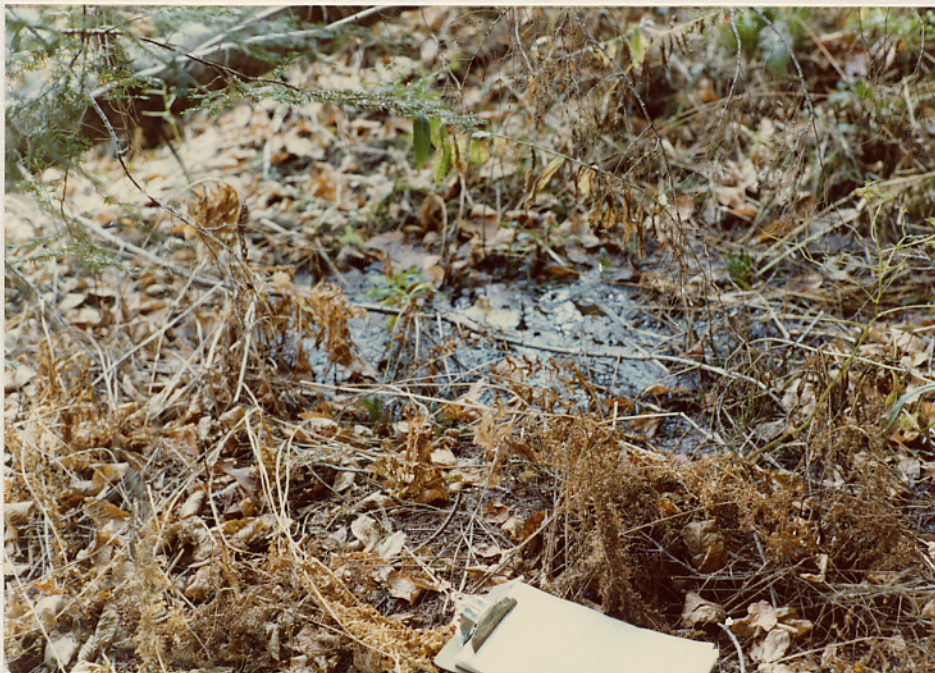
The wet area below the downstream toe on the left side of the dam should be periodically observed to determine whether it is related to dam seepage, groundwater and/or surface runoff. The outlet works (valves, conduit, and operating equipment) could not be inspected.

PHOTO #10: Wet area, downstream of toe at left side of dam.

1) Investigate the significance of the wet area downstream of the dam and recommend measures for monitoring the seepage.

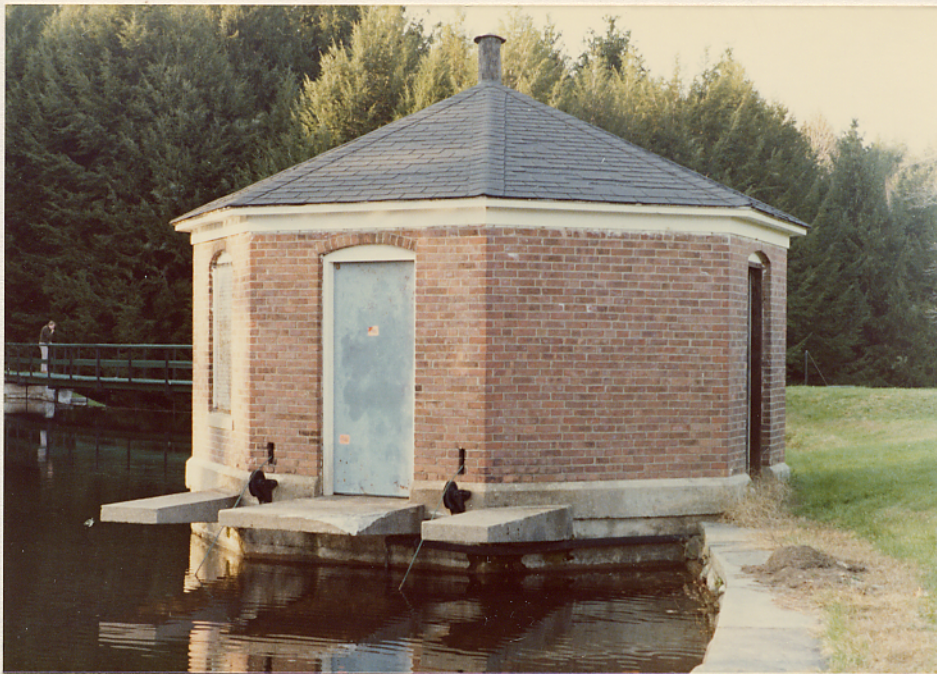
PHOTO #11: Gatehouse.

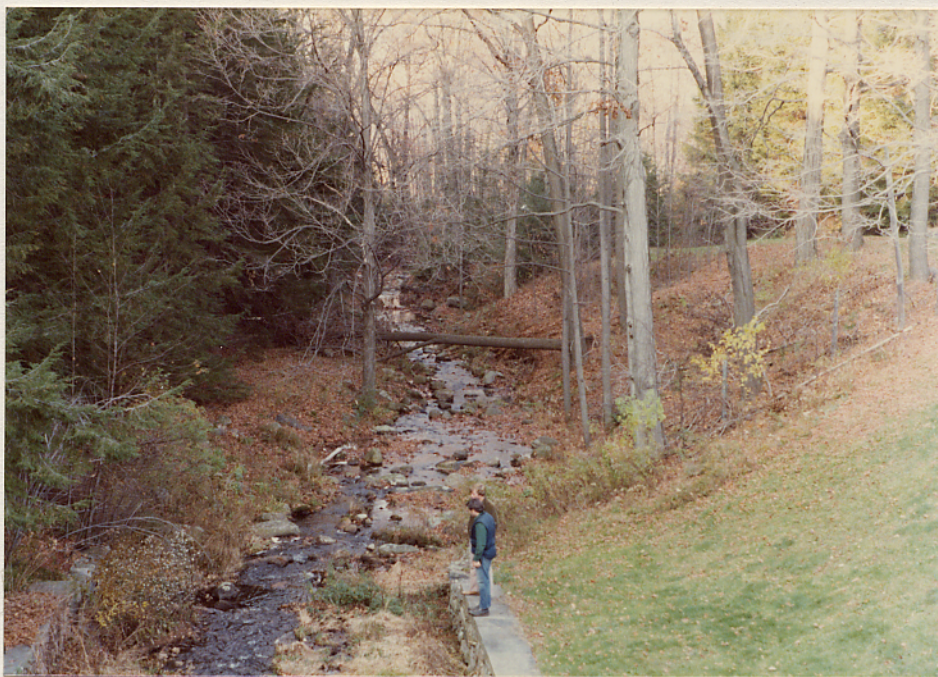
e. Downstream Channel. The natural channel is eight to ten feet wide and has a gravel and cobble bed (Photo No. 12). The banks are well vegetated and stable. An uprooted tree overlies the channel (Photo No. 12). There is no evidence of degradation or aggradation.

PHOTO #12: Downstream channel.

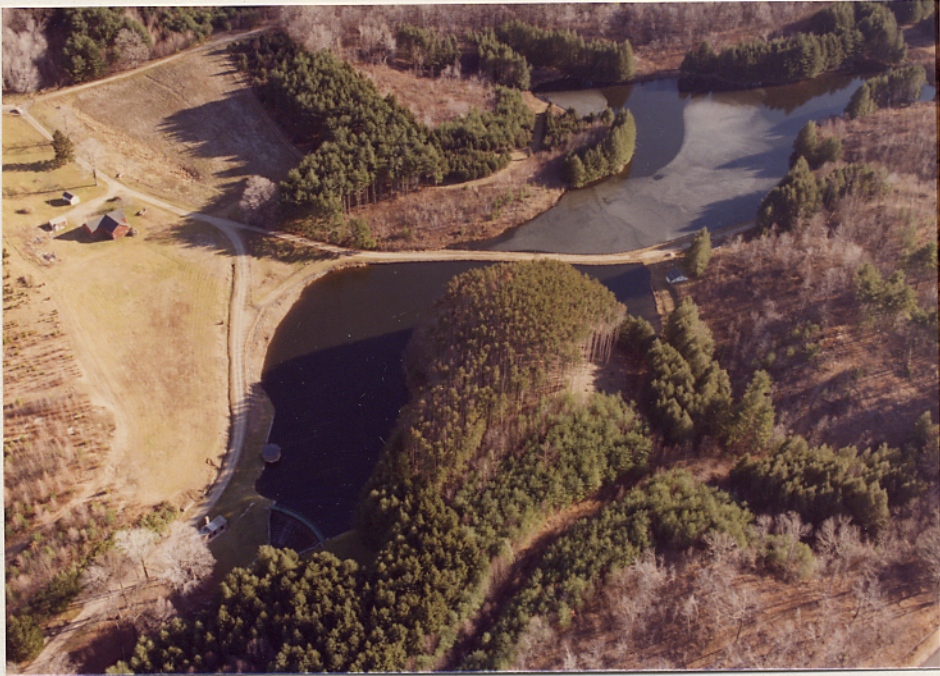
PHOTO #13: Reservoir area.
